SANDYHILLS GOLF CLUB

Advisory Report on the Golf Course incorporating the STRI Programme

Report date: 6th October 2014
Consultant: Ian Craig

Date of Visit: 1st September 2014

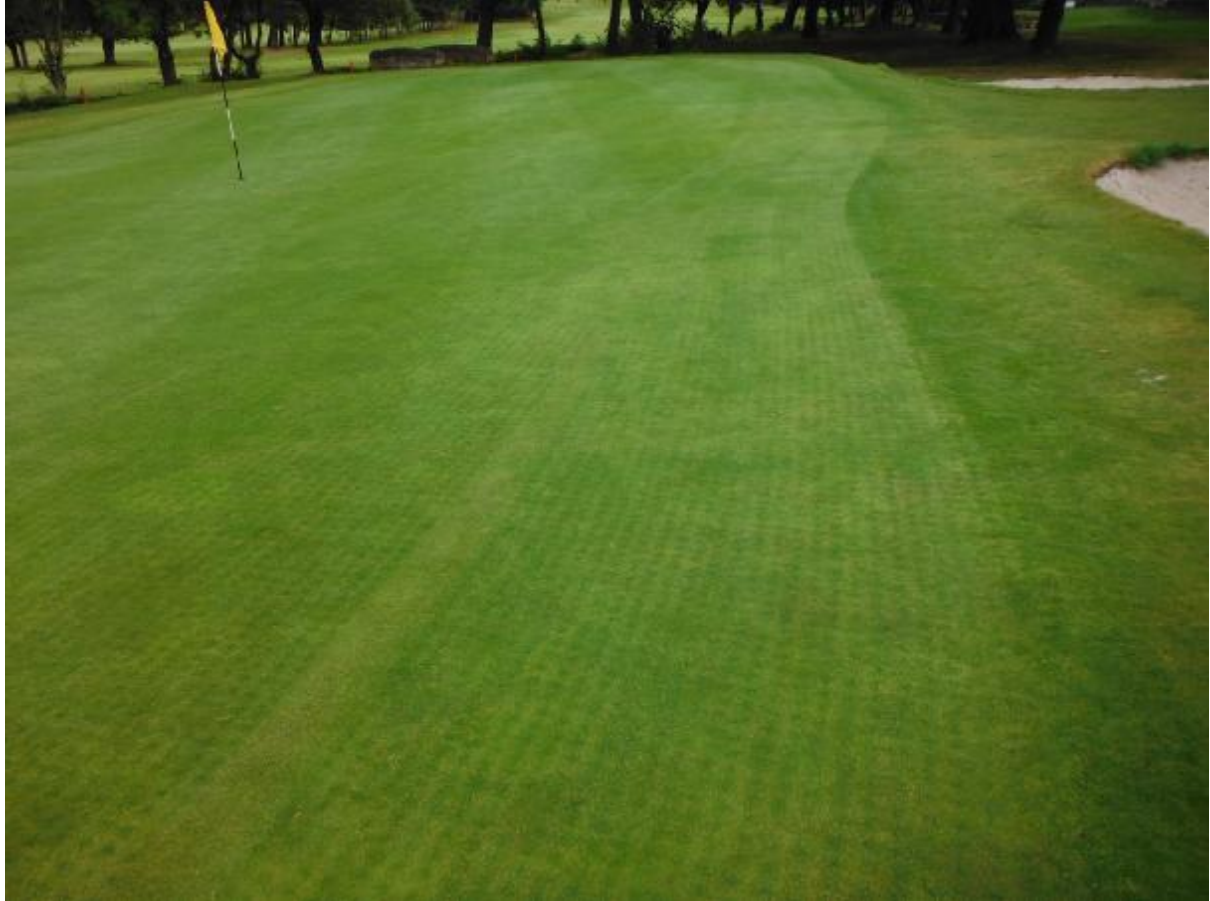
The greens have recovered well from the hollow coring in July, however an increase in top dressing inputs is required as the recovering core holes are having an adverse impact on ball roll qualities.

Evidence of summer hollow coring

- More regular verticutting and top dressing would be required in order to produce more consistently smooth and true surfaces.
- More surface aeration is required and solid tining or slitting would be recommended to create more air fill porosity within the soil and alleviate the black layer noted, particularly in high traffic areas of the greens.
- A soil amendment containing activated charcoal such as Rigby Taylor Blockade may be useful to help 'sweeten' the soil and reduce black layer symptoms.
- Careful monitoring of fertiliser pick up and organic matter breakdown is required over the next 6-8 months to determine whether increasing soil pH is required.

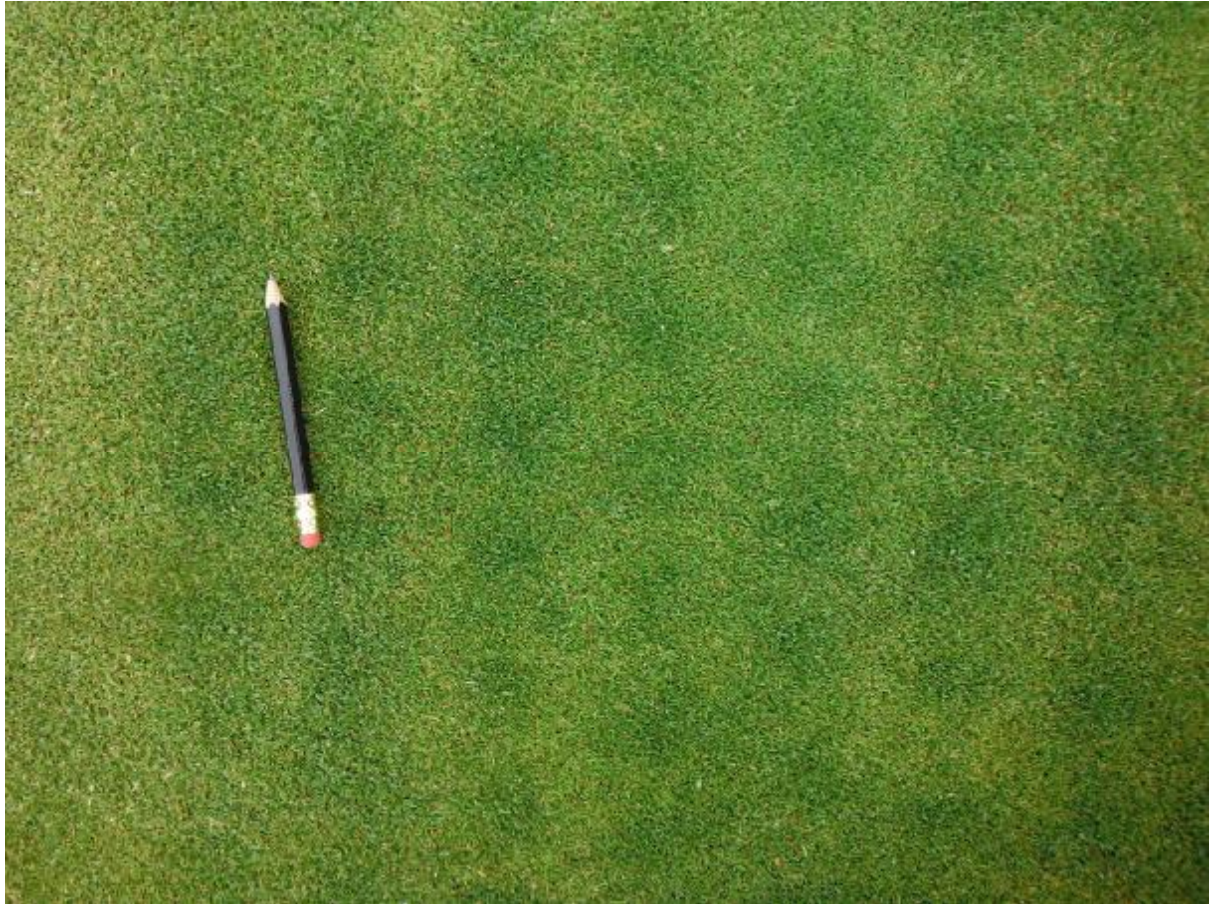
Recovery from coring

There has been no further top dressing of the greens since the hollow coring and, as a result, levels are uneven; particularly around the holes and this is causing some disruption to ball roll.

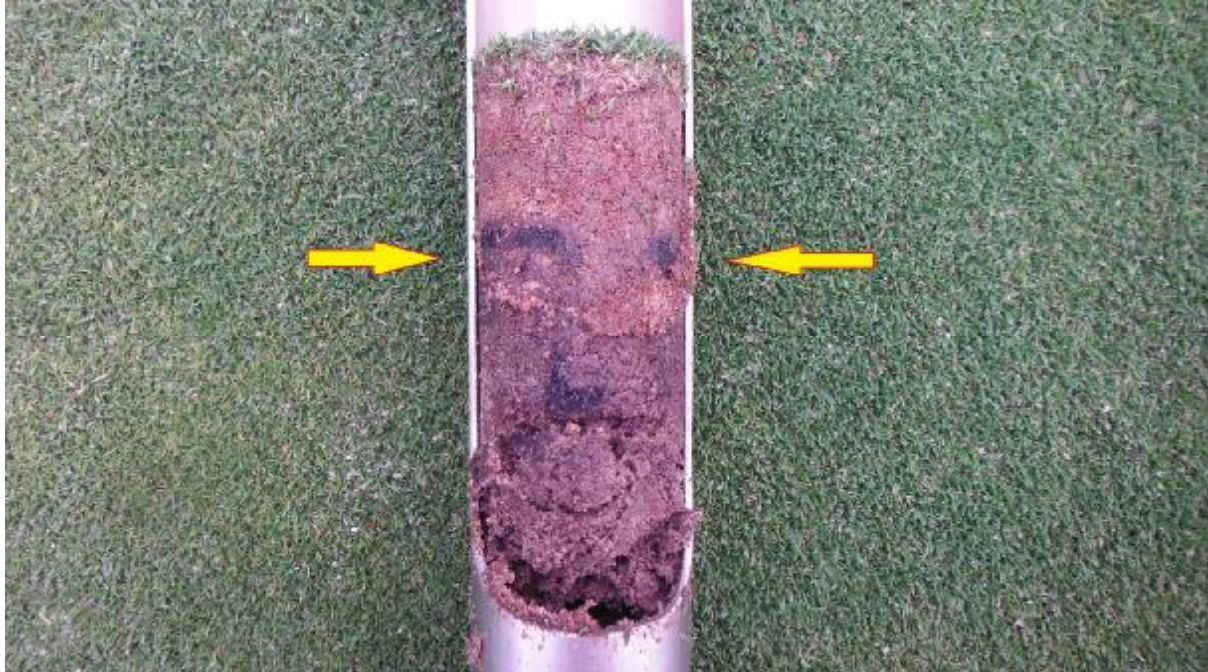
Black layer occurs in compacted or waterlogged soils where aerobic bacteria are unable to respire and the soil becomes dominated by anaerobic bacteria which respire hydrogen sulphate. This hydrogen sulphate gas has a distinct 'rotten egg' smell which is often noted when changing holes on the green.

Black layer 2nd green

The above photograph demonstrates a core taken from the front left of the 2nd green, a low lying area subject to heavy foot traffic. The distinctive rotten egg smell was present and pockets of black layer (metal sulphate deposits) was noted.

The black layer can be combatted by regular aeration, particularly deep aeration where necessary and soil amendments (containing activated charcoal) to reduce the toxic effects of the exudates from black layer.

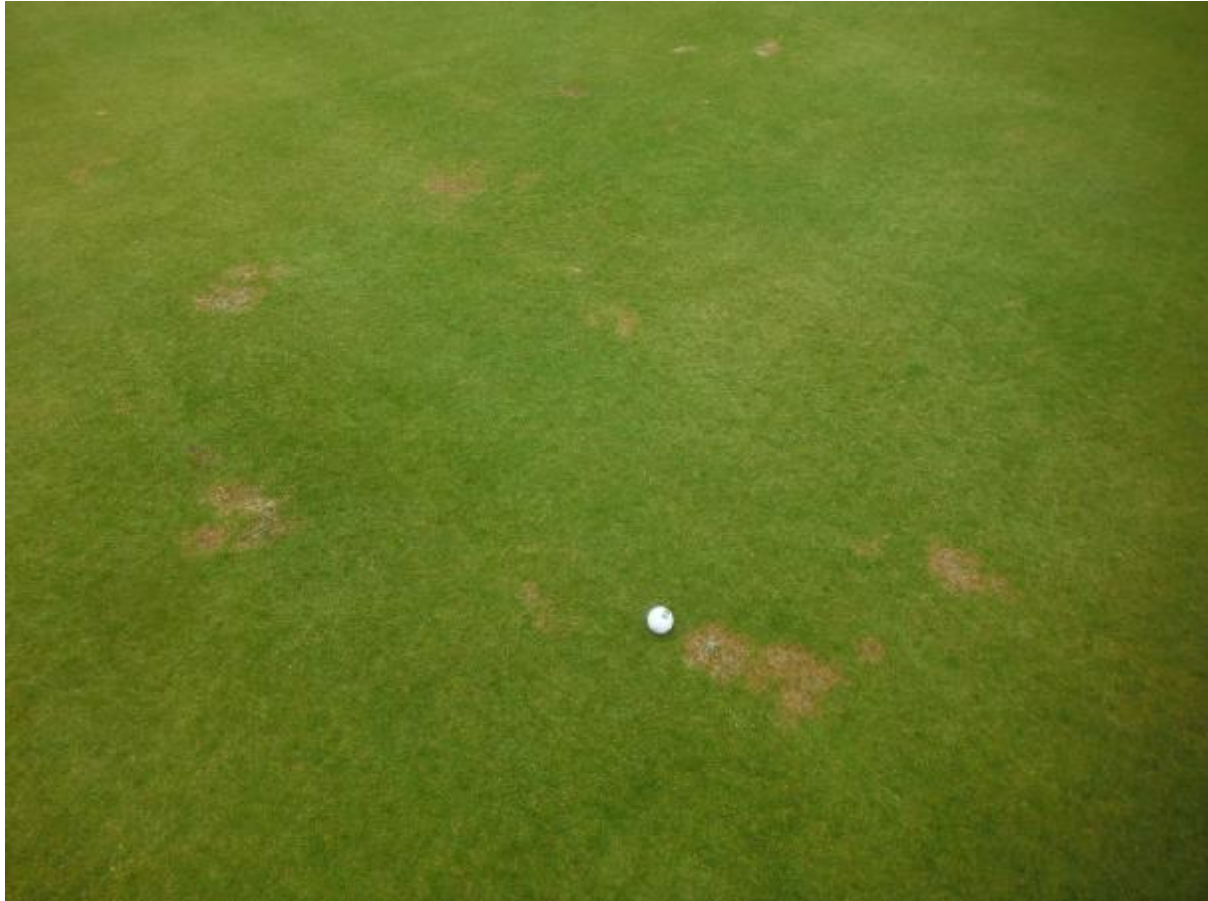
Evidence of microdochium patch was noted on the new section of the green and surround.

Microdochium patch on the new section of the green

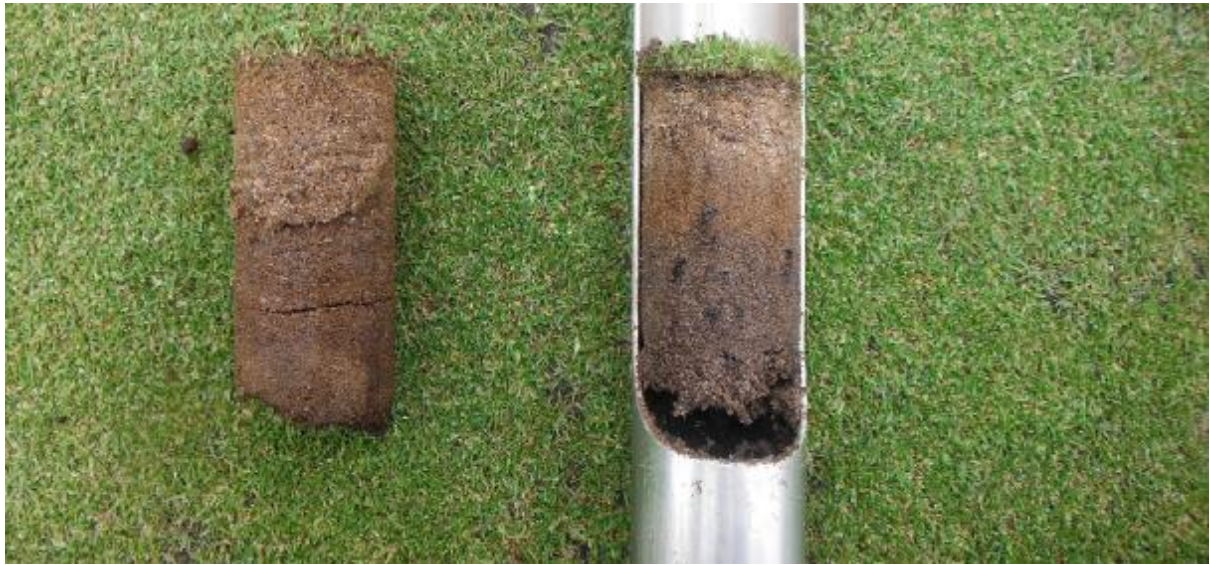
On analysis of the underlying rootzone, we were slightly concerned to see the layering of different sands within the soil profile of the new section of the green. To provide a healthy and free draining rootzone in the long-term, it is important to have a consistent and homogenous rootzone material. Where layering occurs, water movement through the profile varies and rooting can be compromised meaning higher inputs of fertiliser and irrigation (in dry weather) is required. During wet conditions, the layering effects consistent movement of water through the soil and therefore results in black layer development and a further compromise in sward health. It is therefore important to understand the vulnerabilities of this new area of the surface due to the underlying construction. Ongoing aeration and top dressing will lessen the issue with time but the ideal solution would be to reduce the layering via reconstruction.

Cores from the original green (left) and new construction (right)

- We should look to even up the cutting heights of the old and new sections of the 12th green. Raising the height of the cut for winter play in the upcoming months would be an ideal opportunity for this with a view to reducing the height of the old green for the start of the 2015 season.
- Hollow coring and some heavier top dressing of the new section will help to consolidate levels and improve the firmness of this surface bringing it in line with the rest of the greens.
- The microdochium patch should be treated with a suitable contact fungicide such as Instrata.
- Regular deep aeration and top dressing is required to the rear section of this green to help provide consistent water movement through the profile. If this surface deteriorates due to the layering, consideration of rootzone amendment may be required.

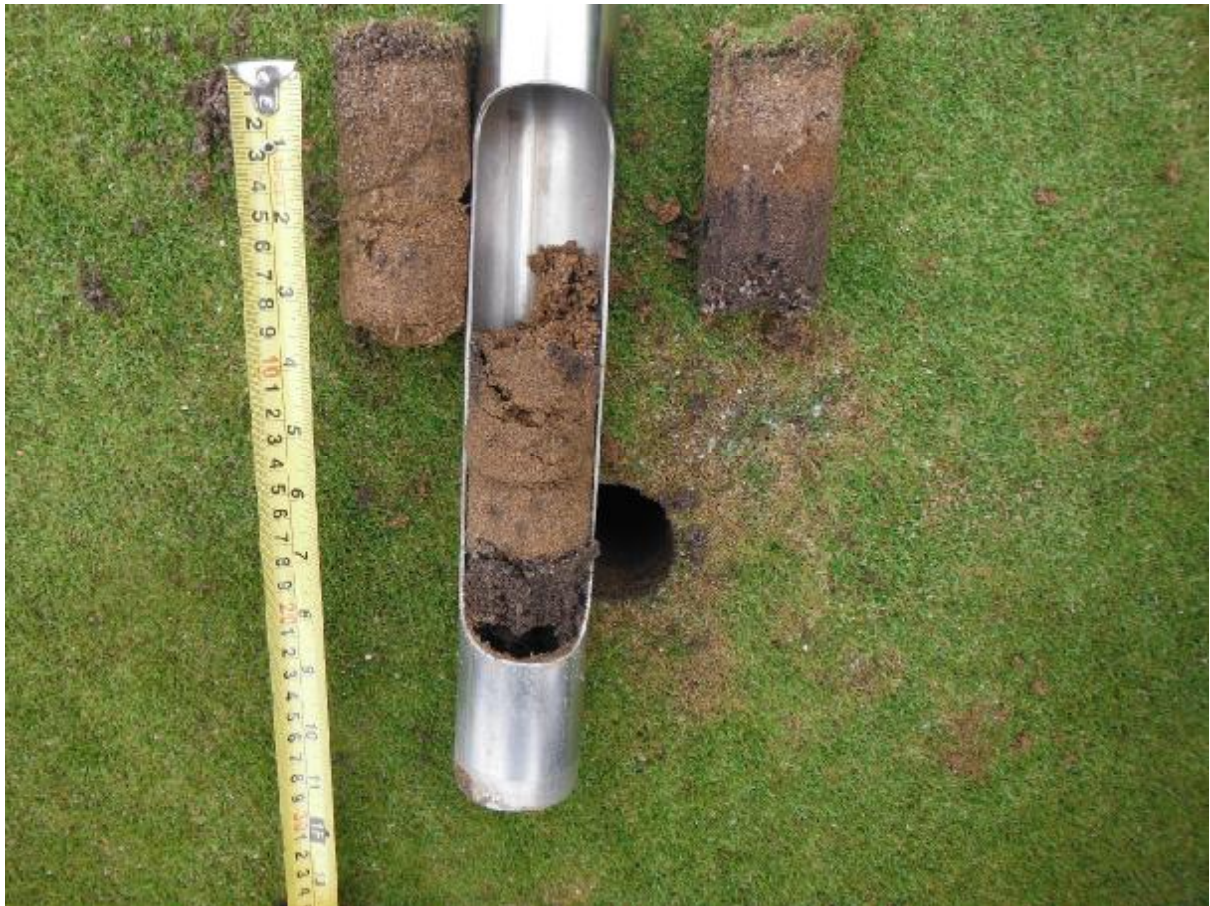
The above photo shows 2 differing sand layering patterns taken from the new section of the 12th green

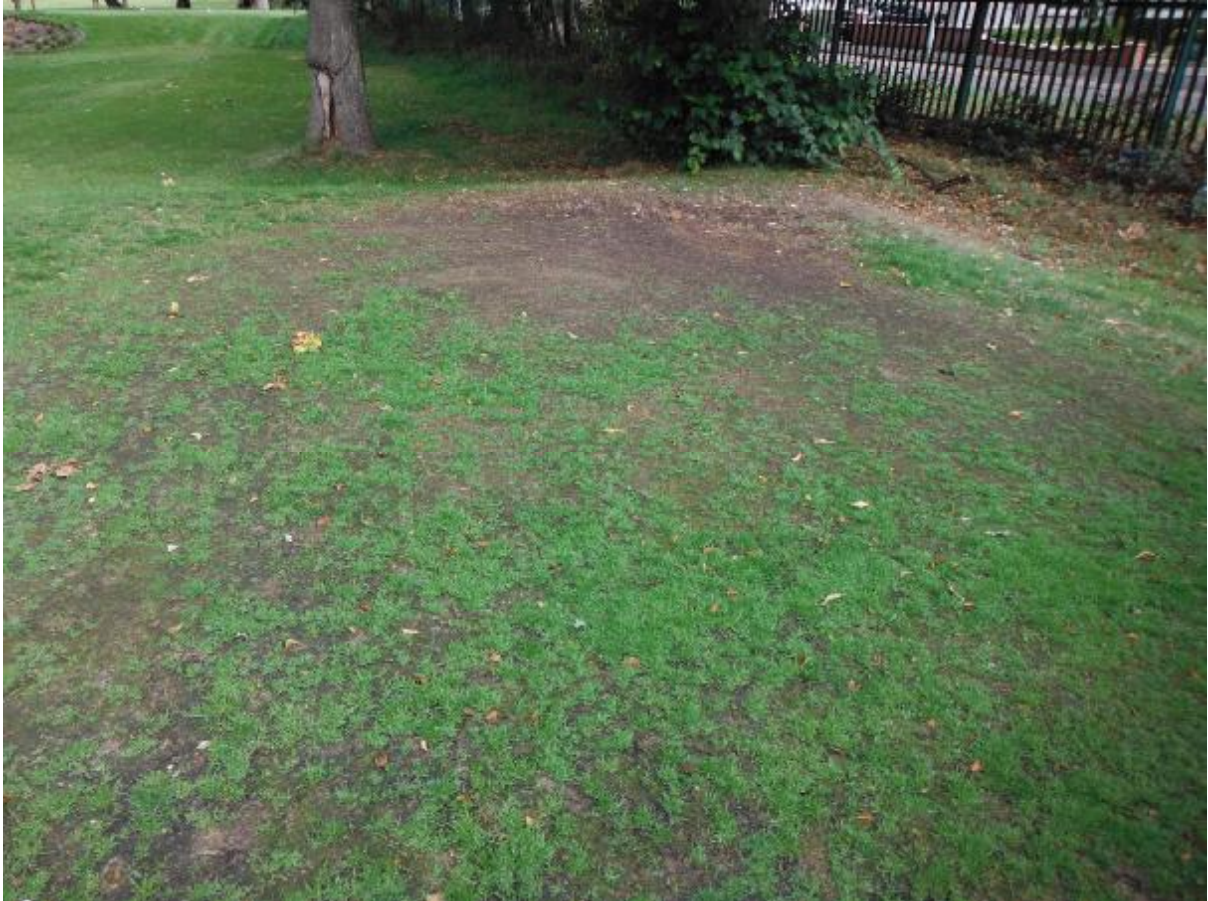
The forward tee on this hole is in very poor condition due to root ingress and dripping from the overhanging tree canopy. Immediate action is therefore required to improve the turf cover and presentation of this surface.

3rd forward tee requires immediate action to improve grass cover

- The newly turfed back tee on the 3rd requires hollow coring and top dressing in order to remove and dilute as much of the thatch layer from the turf as possible. This will help to achieve a more uniform soil profile.
- We discussed possible options for the forward tee on this hole in order to achieve adequate grass cover. The most effective way to improve turf quality would be to remove the overhanging tree as roots are leading to lack of available soil moisture for the turf and dripping and shade from the overhanging canopy is making re-establishment of grass cover very difficult.
- Another option would be to move the tee to the right, however this would bring the trees on the right hand side of the fairway very much into play and possibly require removal of some of these.

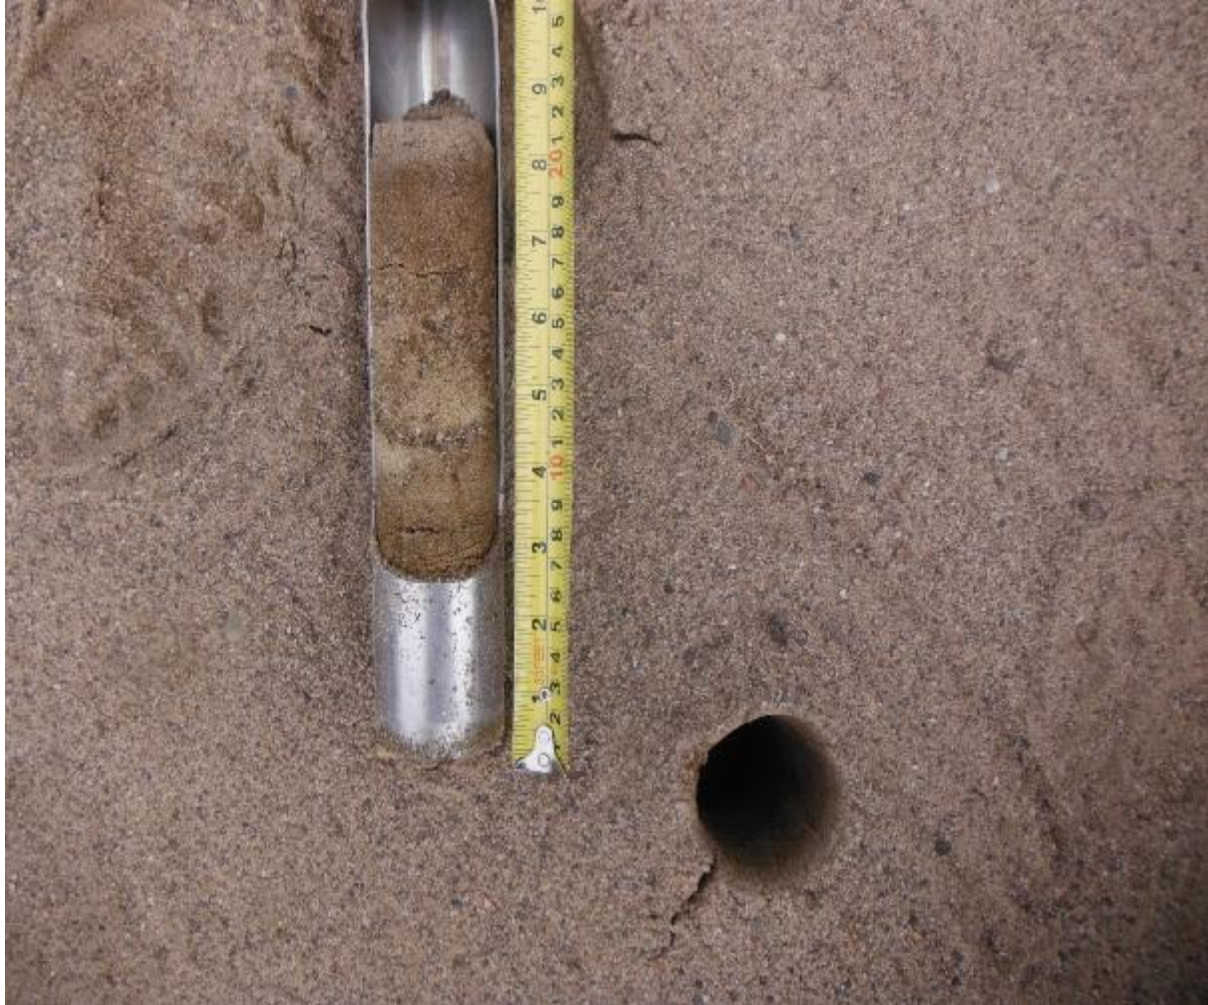
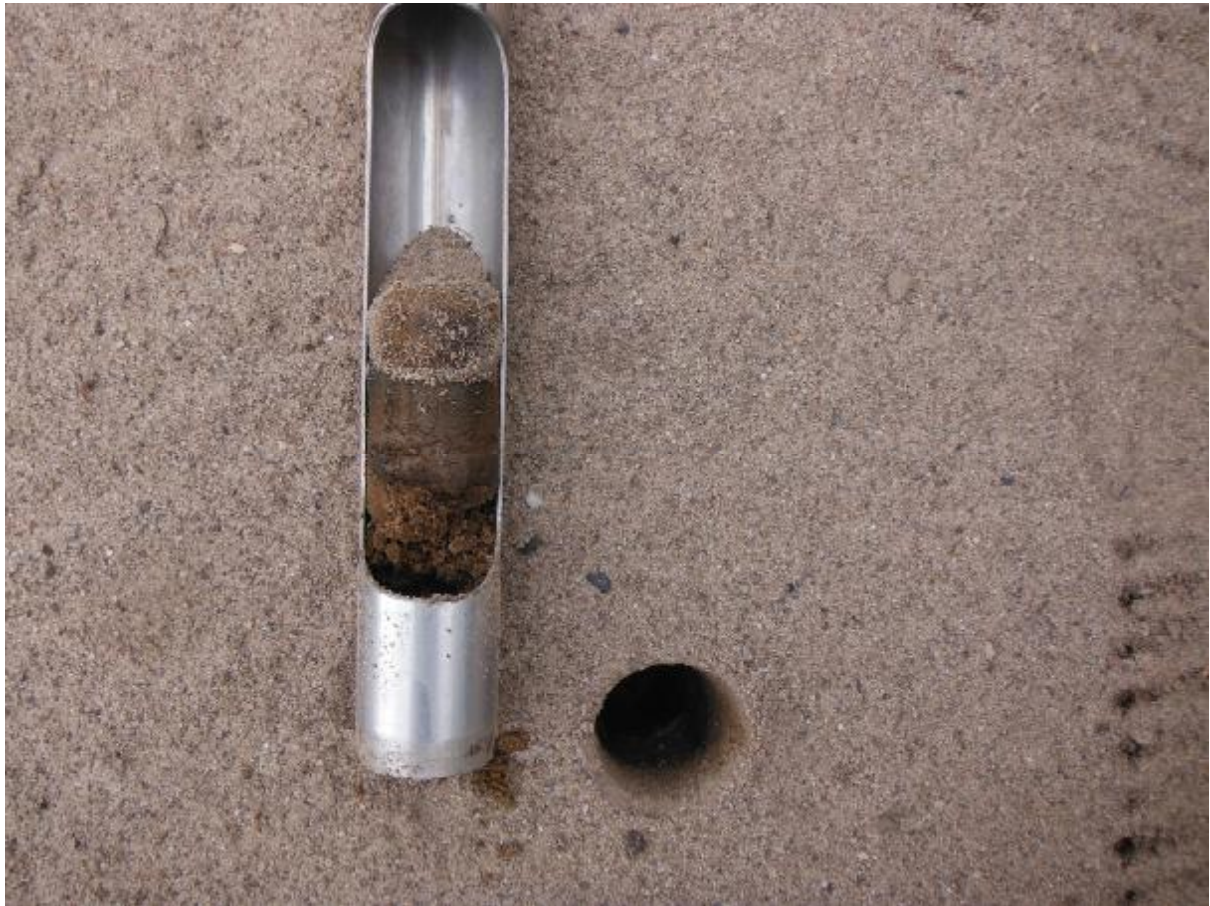
The sand levels in the bunkers is variable and some extensive work is required to correct these. In some bunkers there was a difference of 6-7 inches in sand depths within the same bunker and this will result in variable playing qualities.

Re-edging the bunkers year on year will lead to uneven bases particularly on the faces of greenside bunkers and this was evident in the bunkers we looked at during the visit.

Variable sand depth in bunkers

The above photos were both taken from the same bunker within a few metres of each other and show 9 inches of sand in one area and little over 1 inch in the other. The surface levels within this bunker appeared to be good, indicating that the base requires reshaping.

- The bunkers are in need of attention and it would be worthwhile to prioritise starting with the greenside bunkers.
- The bases have become very uneven following years of play and regular edging and these bases need to be re-levelled in order to have appropriate depths of sand and not lose the shape and characteristics of the bunkers.

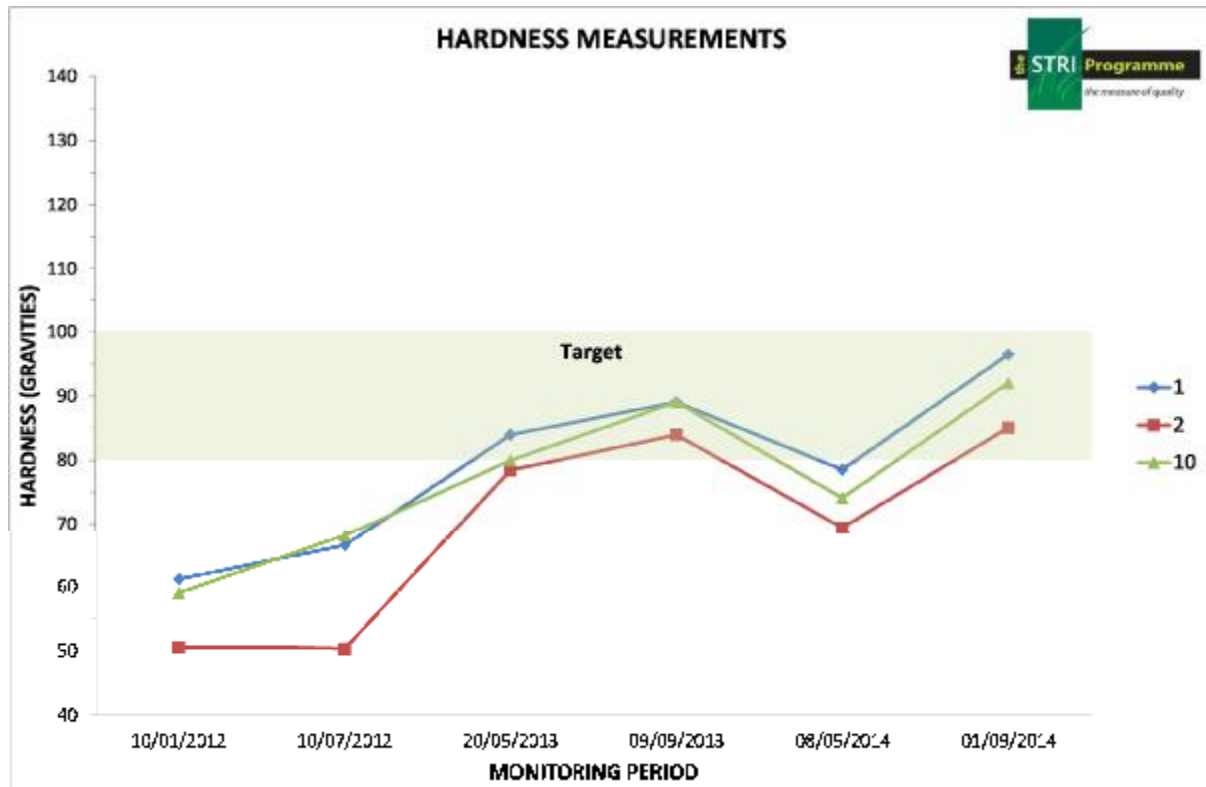
- The firmness was within routine target across the three indicator greens, albeit towards the lower end of the target and some variation from green to green was noted.
- With an average firmness of 85 gravities the 2nd green was just inside routine target range. This low lying and sheltered green was noticeably moisture retentive within the upper 40mm of the profile and was seen to have a visible black layer further down the profile.
- The hardest green was the 1st with an average of 96 gravities and the 10th at 91 gravities was also comfortably within the target for routine play.
- The 1st and 10th greens were also visibly drier than the 2nd and no evidence of black layer was noted on these greens.

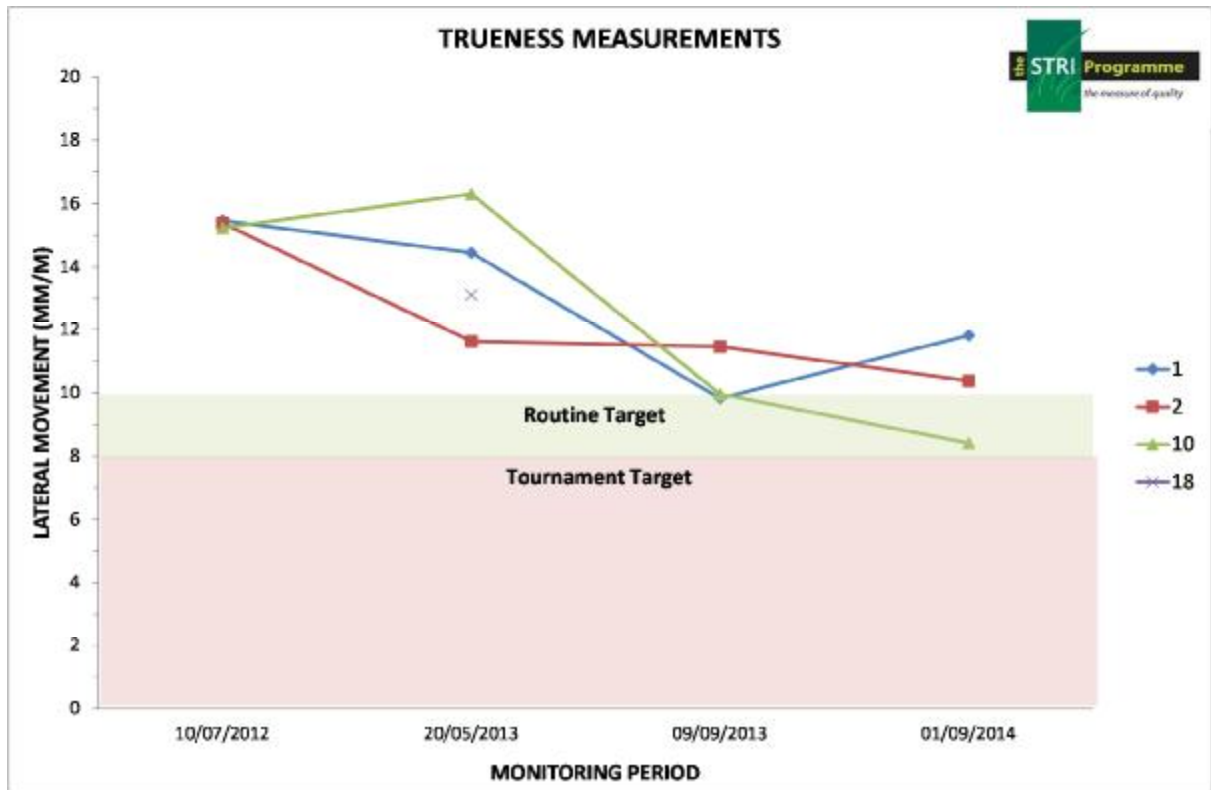
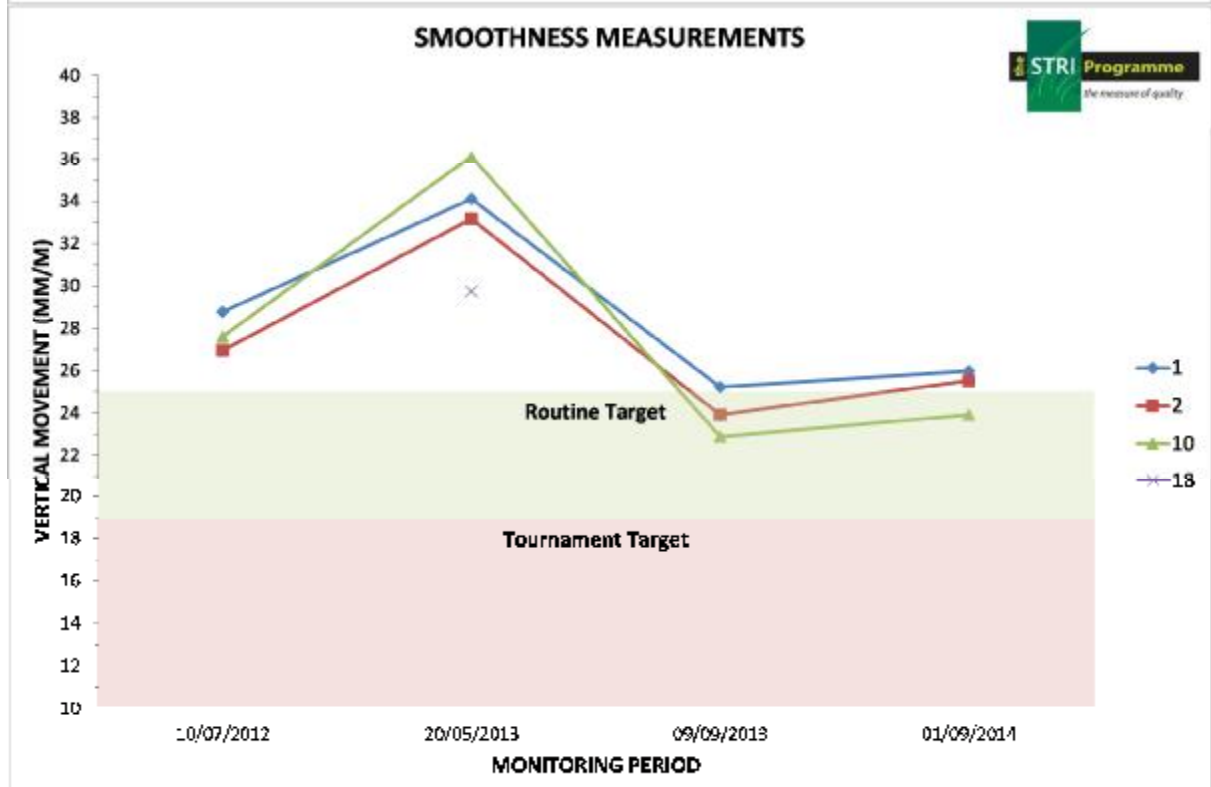
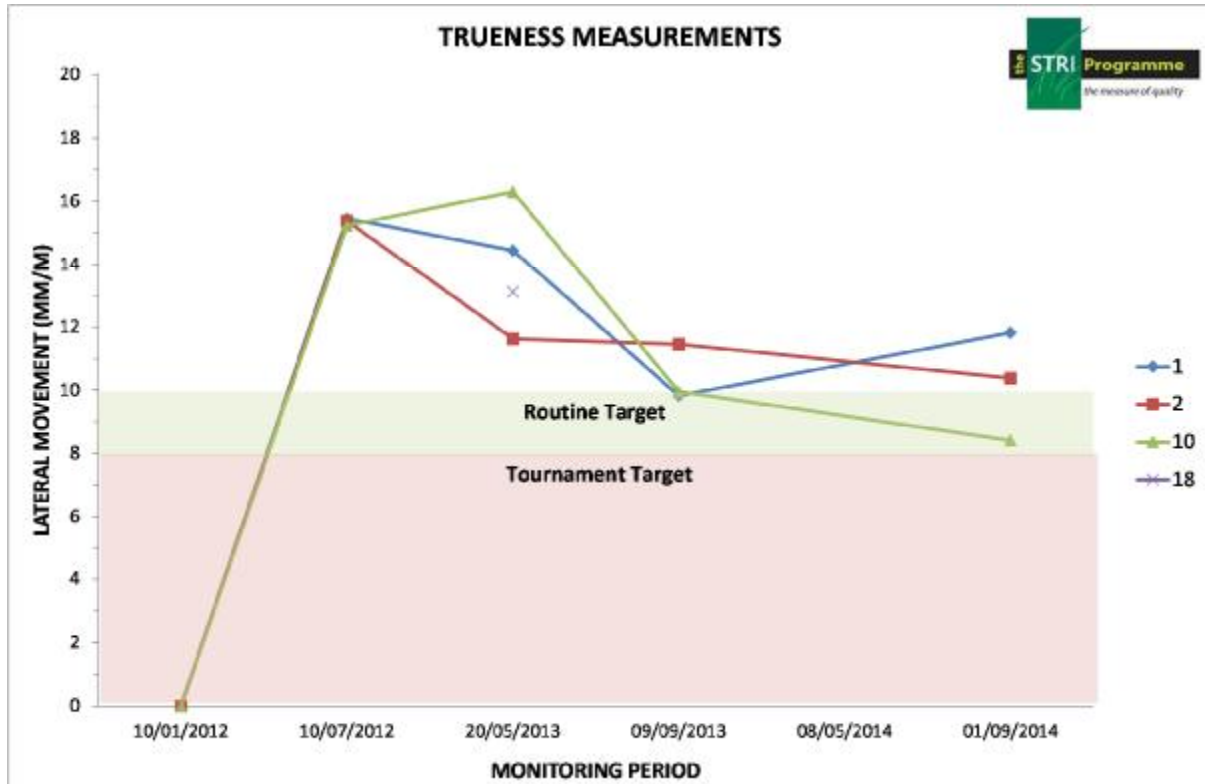
- The target range for routine smoothness is 19-25mm/m and with average readings of 25.5 mm/m and 26mm/m the 1st and 2nd greens fell just outside of this target. The 10th green, which is generally considered to be the best green had an average smoothness of 24mm/m and was just inside the target range.

- Similarly the trueness readings for greens 1 and 2 were outside the ideal target range of 8-10mm/m and green 10 was on target with an average trueness of 8.4mm/m.

- Recovery from the July hollow coring has been good, however the lack of routine top dressing following this process has resulted in readings for smoothness and trueness being higher than we would ideally like to see at this time of year.

- Heavy top dressing following hollow coring is essential in order to back fill the hole with a suitable sand, however it is necessary to follow up with repeat top dressings at a lighter rate in order to maintain a smooth and true surface as the sand will quickly settle and levels will become uneven.

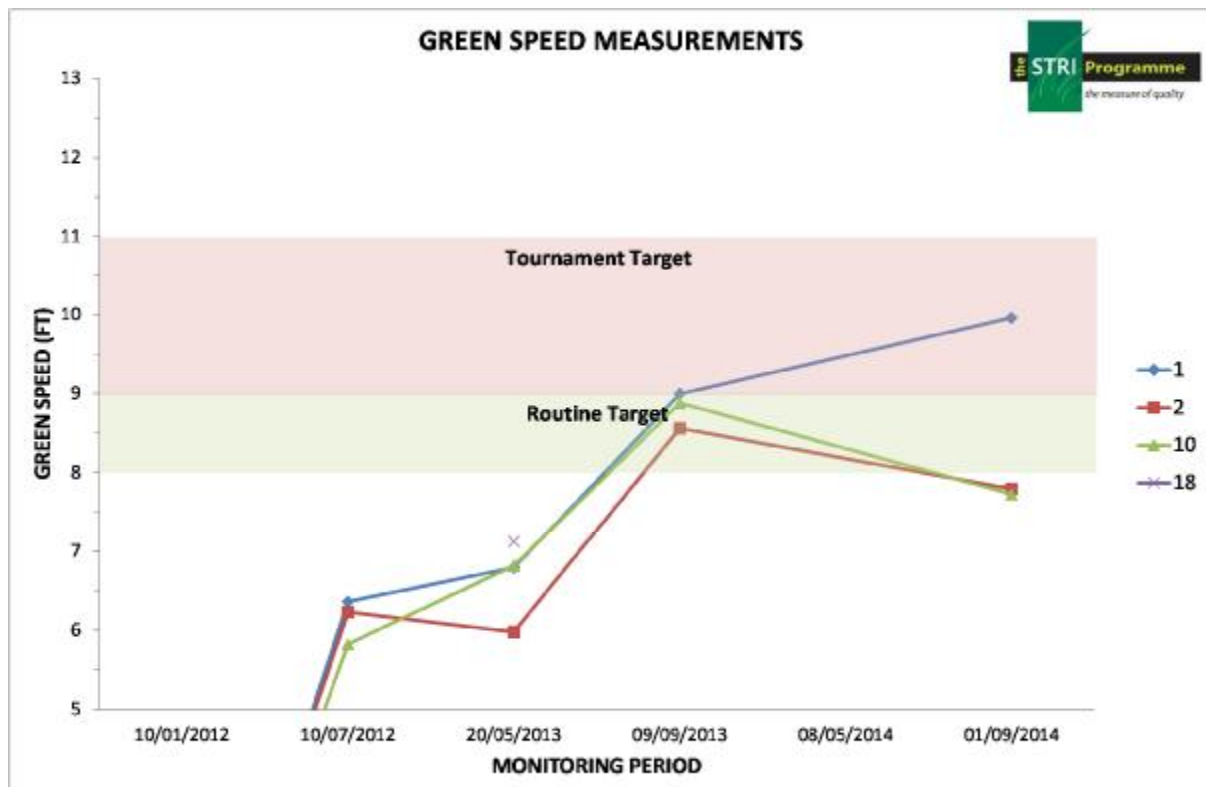
- Green speed on greens 2 and 10 was very consistent and just outside routine target at 7ft 8in and 7ft 7in respectively.
- At 9ft 9in the 1st green was significantly quicker and well within the tournament target range.
- A pronounced difference in green speed is likely to be problematic for players and should be regularly monitored with the use of a Stimpmeter in order to keep green speeds as consistent as possible from green to green.

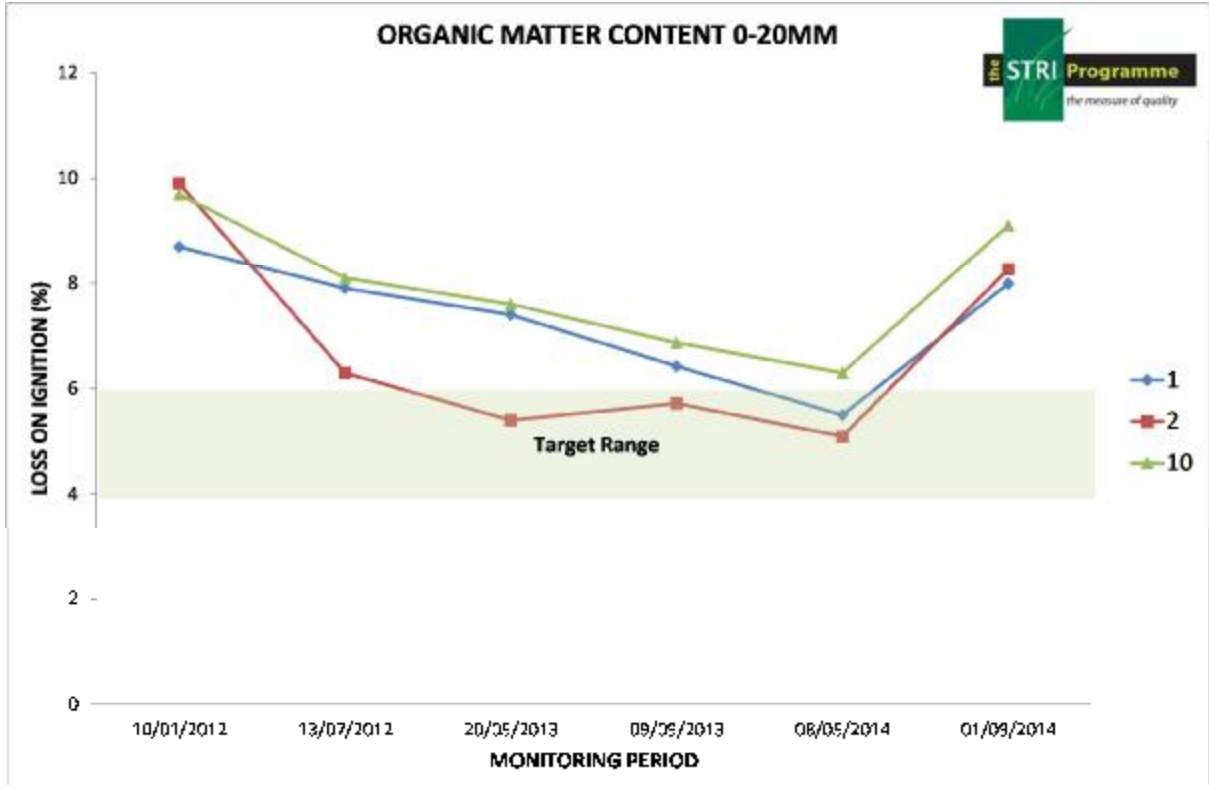
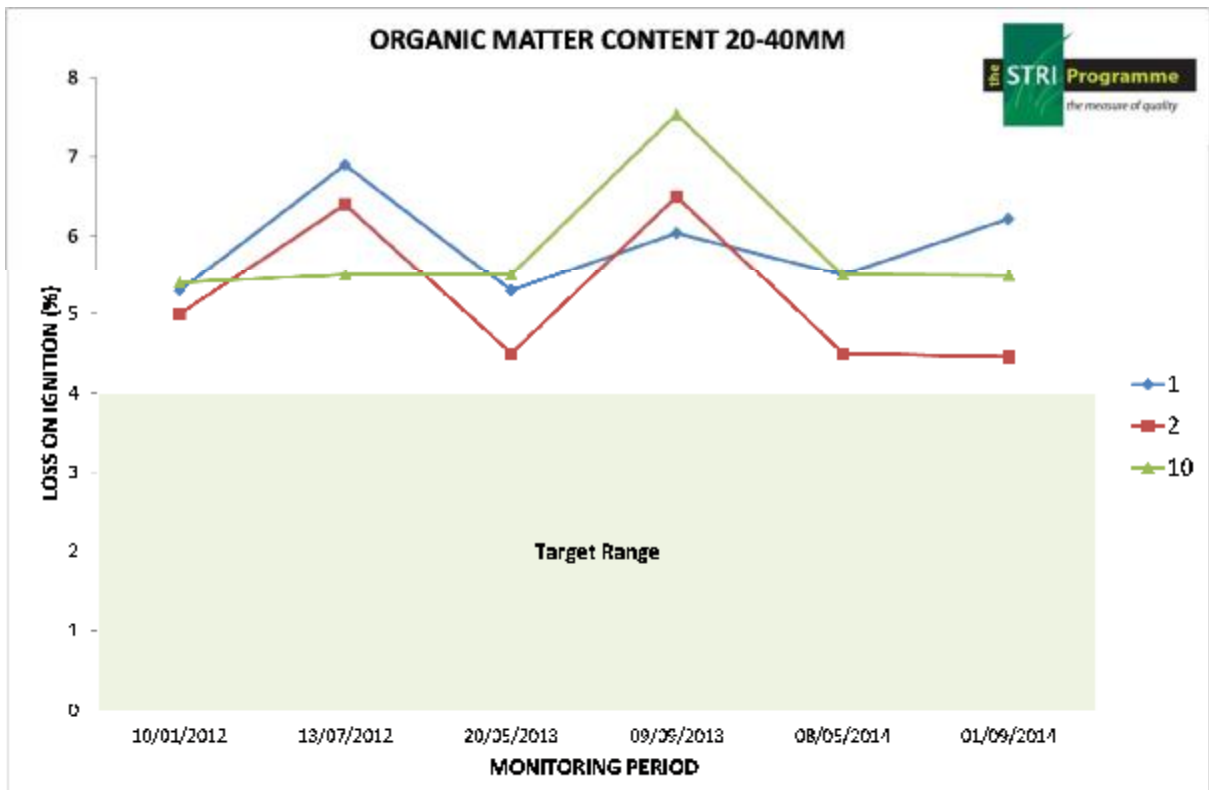
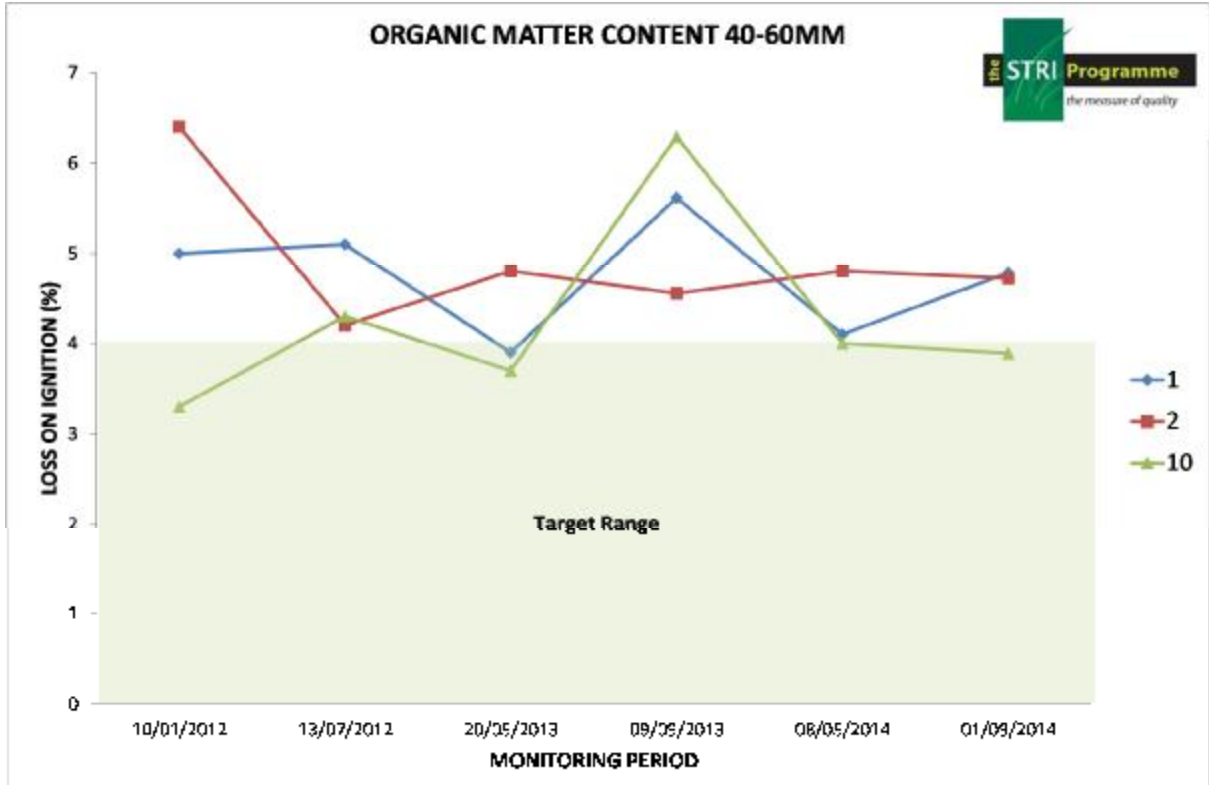
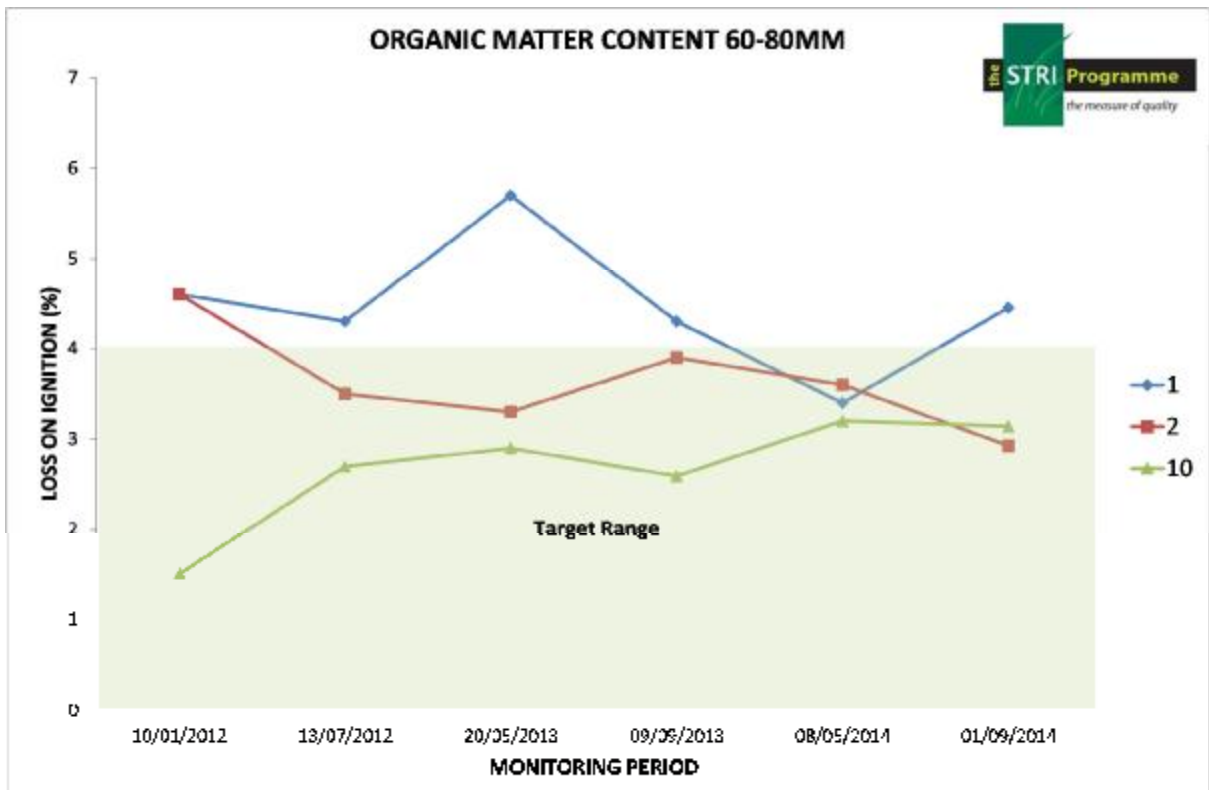
- Despite a very pro-active approach to organic matter control involving spring and autumn treatments with the Graden sand injection scarifier and a midseason hollow coring, we have seen a notable increase in organic matter from the spring samples, particularly within the upper 20mm of the soil profile.

- It is likely that the increase is due to a lack of sand top dressing through the season and perhaps excessive growth from high nutrient inputs and the very low soil pH.
- Recommendations would be to continue with the planned Graden treatment again in the autumn and we will take further samples for analysis again in the spring.
- It is extremely important that regular top dressing inputs are implemented as this, in conjunction with verti-cutting, will help to minimise a further build-up of organic material as well as diluting that which is already present in the upper profile.
