# Sandyhills Golf Club

## Advisory Report on the Golf Course Incorporating the STRI Programme

Report Date: 14<sup>th</sup> May 2015

Date of Visit: 27<sup>th</sup> April 2015

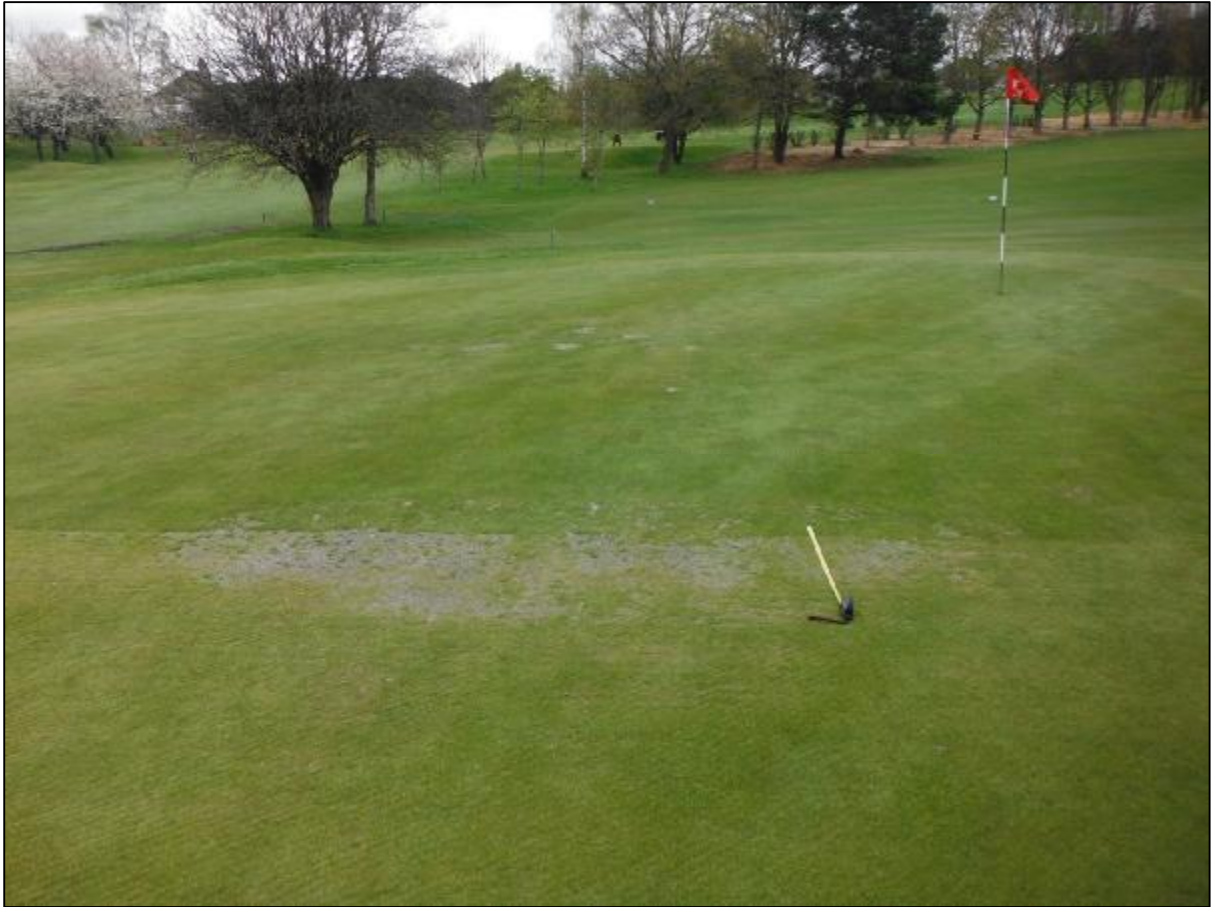
## 12<sup>th</sup> Green

The 12<sup>th</sup> green continues to be an issue in terms of playability. The outbreak of take all patch experienced in 2014 was controlled with a sensible application of Heritage Maxx fungicide and recovery from this damage has been good following overseeding with fescue. There remains to be issues with the joining section between the old and new parts of the green, surface levels remain uneven and a collection point in the middle of the green remained underwater for long periods resulting in a loss of grass cover (as shown in the above photograph) which will require re-turfing. When re-turfing work is carried out attention must also be paid to the surface levels to ensure no repeat of this issue.

- The bare patch in the middle of the green totalling around 5m<sup>2</sup> will require re-turfing. Turf could be harvested from either a putting green or the outer perimeter of the 12<sup>th</sup> green bringing the cutting line in to allow regeneration of this area. Before re-turfing levels must be adjusted to ensure that no low areas are present as this will lead to a collection of water and further damage to the area.
- An increase in topdressing, particularly to the back section of this green would be necessary this combined with regular rolling will help to firm up this surface and even out the playing qualities across the surface allowing the entire green to be used for play thus minimising damage to the front section which is regularly in use at the moment and suffering high levels of wear and tear.

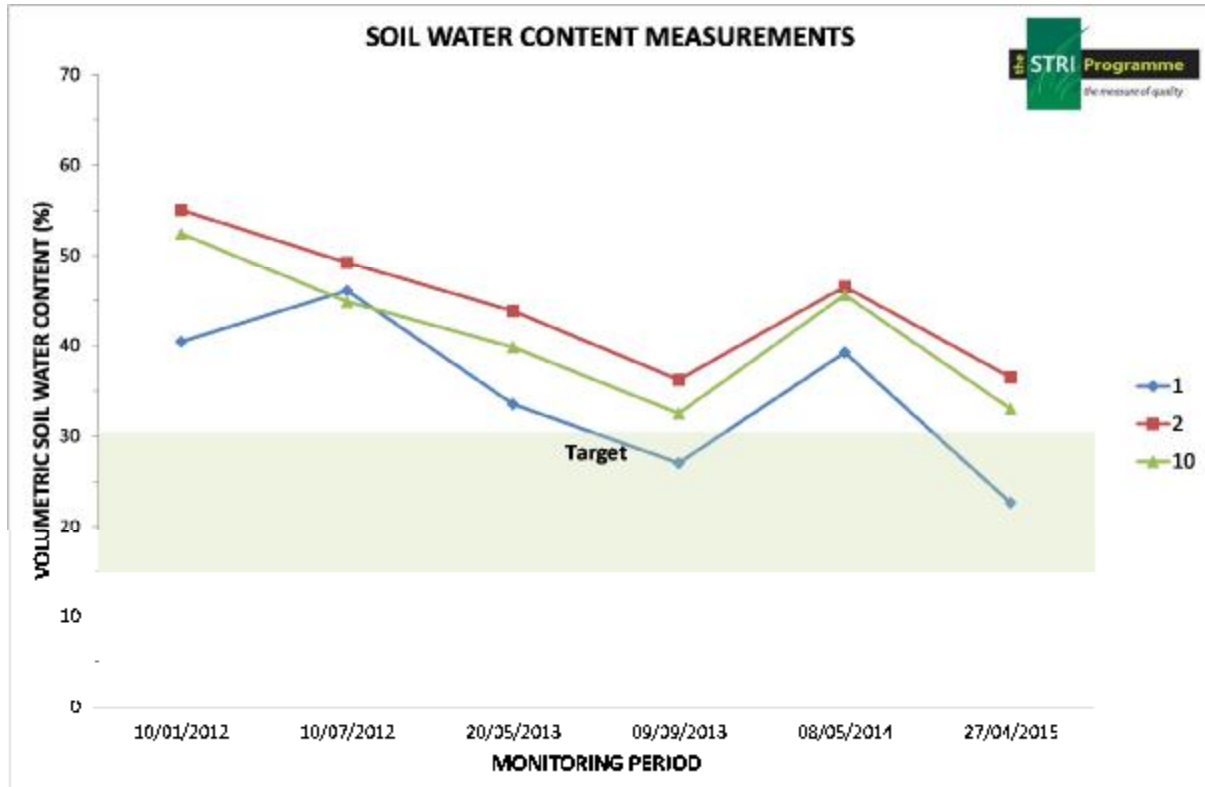
Figure 1

Performance Measurement Results							
Green No.	Speed (distance)	Smoothness (mm/m)	Trueness (mm/m)	Firmness Mean (gravities)	Firmness SEM (±)	Moisture Content (%)	Moisture Content SEM (±)
1				126	2.9	22.7	1.7
2				104	2.3	36.5	1.0
10				113	3.3	33.0	0.6
