ARBORICULTURAL AND WOODLAND MANAGEMENT ASSESSMENT AND REPORT

**GRIMSBY GOLF CLUB
LITTLECOATES ROAD
GRIMSBY
DN34 4LU**

CLIENT - GRIMSBY GOLF CLUB LTD

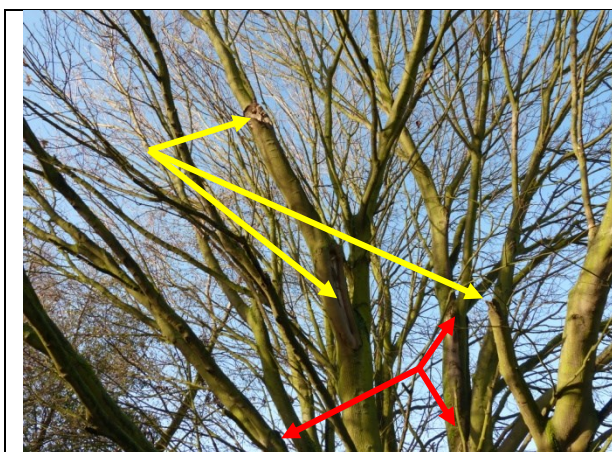
Picture 1 - Norway maple in the group of four trees immediately south of the 9th green showing the sites of six included fork unions. Previous failure points are arrowed in yellow, existing weaknesses are arrowed in red.

Copse number or individual tree species	Location	Constituent species (copses) or individual tree details
C1	North of 1st fairway	<i>Acer platanoides</i> 'Crimson King' (Purple Norway maple), <i>Alnus cordata</i> (Italian alder), <i>Betula pendula</i> (Silver birch), <i>x Cupressocyparis leylandii</i> (Leyland cypress), <i>Larix x eurolepis</i> (Hybrid or Dunkeld larch), <i>Pinus nigra nigra</i> (Austrian pine), <i>Pinus sylvestris</i> (Scots pine), <i>Prunus x 'Kanzan'</i> (Japanese cherry), <i>Prunus laurocerasus</i> (Cherry laurel) and <i>Quercus robur</i> (English oak). Various trees have been selected and marked for removal under the proposed thinning regime. The crowns of remaining trees can be lifted to 4m above ground level if required. The cherry laurels can be coppiced to 30mm above ground level.
Norway maple	Extreme east end of C1, over-shadowing 9th green	Group of 4 trees, all containing bark inclusions in multiple forks, several of which have failed in recent years. All four trees should be removed.

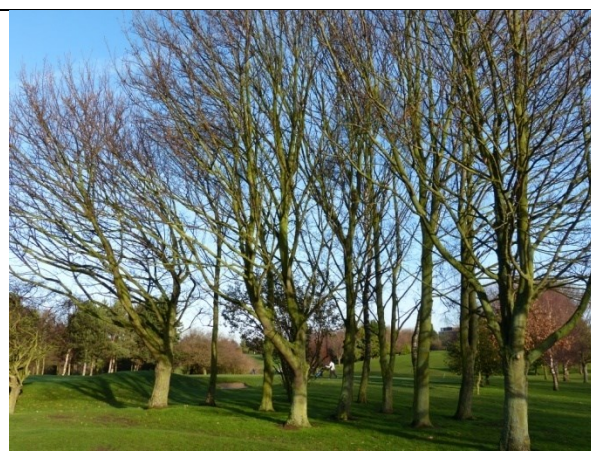
Picture 2 - Sycamores forming copse C2 immediately north of the 18th green. The asymmetric tree on the left overshadows the green and is marked for removal. Other trees within the group will be thinned out to create space for the superior specimens.

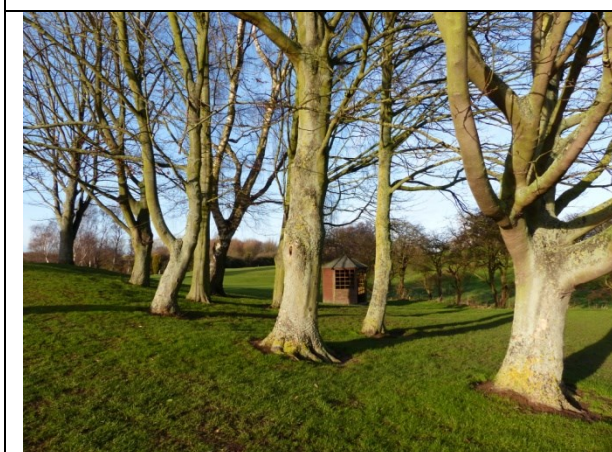
Picture 3 - Sycamores in copse C4, north of the 14th green. Poor quality trees such as the forked tree arrowed will be removed as part of the thinning of the

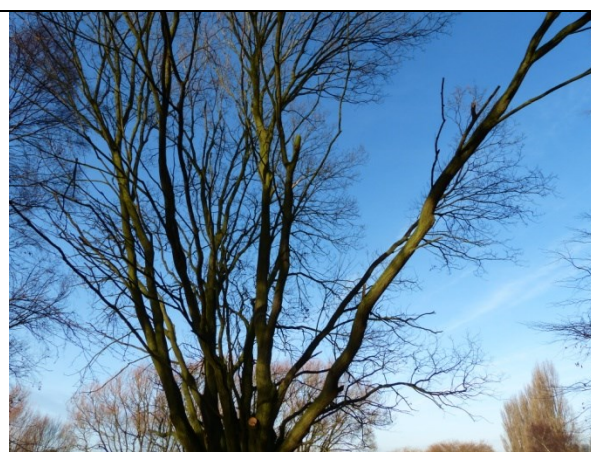
Picture 4 - Goat willow in copse C3 beside the 16th fairway showing the misshapen crown with significant storm damage and dead wood. The tree is
